Insulation Materials

Reference Bulletins CBI Bulletin No. 2 Negative Radius Insulation Jackets

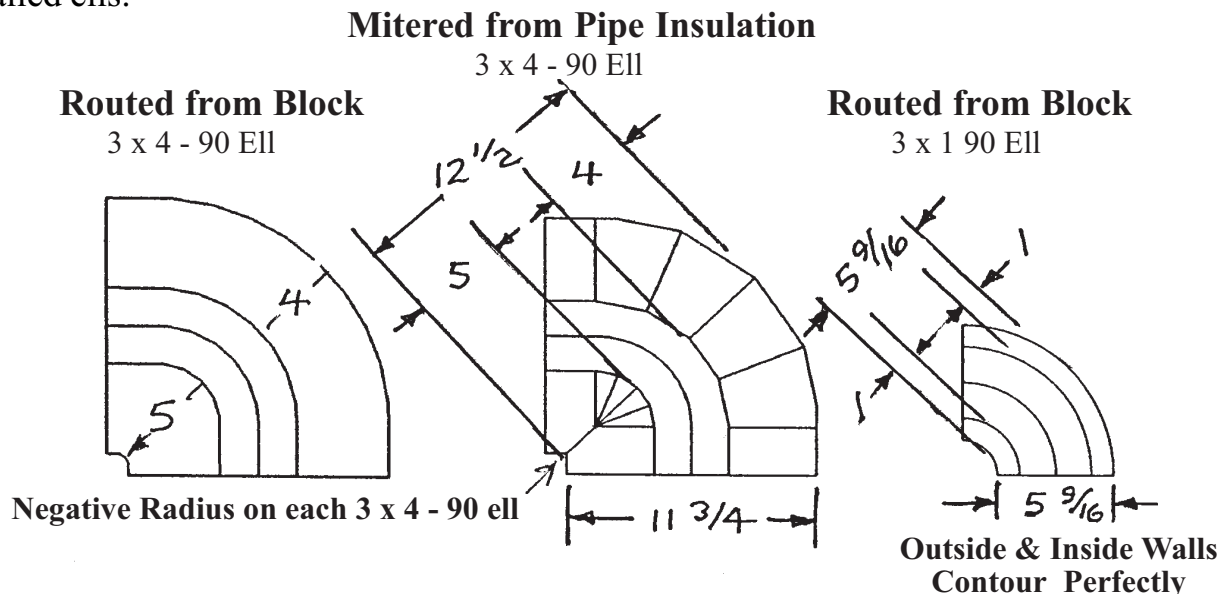
The problem occurs because the inside radius (or throat) of the insulation disappears with a thick wall. Even though the outer radius contours perfectly with the iron elbow, there is no inside throat radius.

Thick walled ells lose their sweeping appearance when the wall thickness approaches or exceeds the pipe size. They become “humped” ells even though they are perfectly contoured long radius covers.

As a consequence, the OD and circumference is greater in the throat area than the regular OD at either end of the elbow. This holds true for all thick walled ells whether the ells are fabricated from miters or from solid blocks. Refer to examples below.

Contractors and/or owners should take these problems into account when bidding jobs with thick walled elbows. Cook Brothers Insulation cannot assume responsibility for extra labor charges associated with field fabricating metal to fit thick walled ells.
